MISCELLANEOUS PAPER SL-81-17

STRUCTURAL STABILITY EVALUATION SANDY LAKE DAM

Carl E. Pace

July 1981

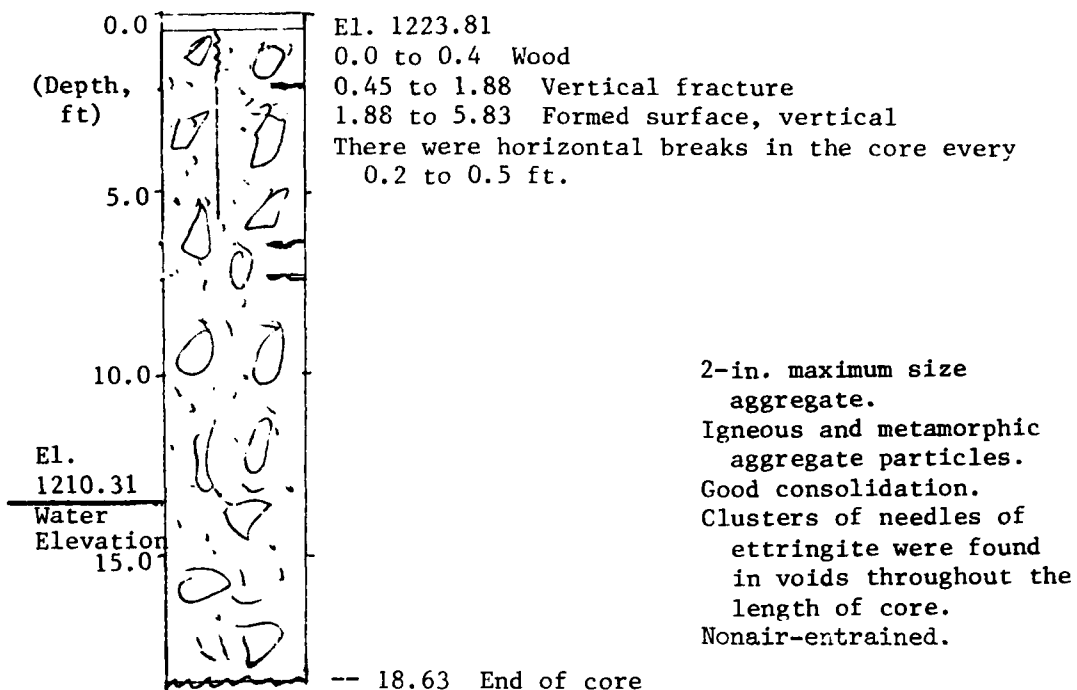
Figure 6. Vertical NX concrete core, S-P1, Sandy Lake Dam

28. The nonair-entrained concrete of both cores was similar. Core S-P1 was broken at intervals of 0.2 to 0.5 ft along its entire length. Core S-P5 was broken at intervals of about 0.4 ft below a depth of 4.5 ft. The breaks appeared to be new and were believed to be due to the drilling operation. Since the concrete appeared similar, the greater frequency of breaks in core S-P1 was also ascribed to the drilling operation. The concrete was well consolidated. Maximum aggregate size was judged to be 2 in. in core S-P1 and 1-1/2 in. in core S-P5. The coarse aggregate was composed of granite, granite gneiss, and fine-grained, dark colored, igneous rock particles. The mixed composition and particle shape suggested this was gravel and that some crushing may have been used. The fine aggregate was the same material with more single grains of quartz and feldspar. The logs of these cores are shown in Figures 6 and 7.

31. The concrete from this structure as represented by the cores appeared to be homogenous. The increase in the frequency of breaks in some of the concrete cores is believed to have been due to the small core size and the drilling procedures. Larger diameter cores would probably have improved the condition of the cores. The vertical fracture found at the top of S-P1 is probably related to the cold joint aligned with it.

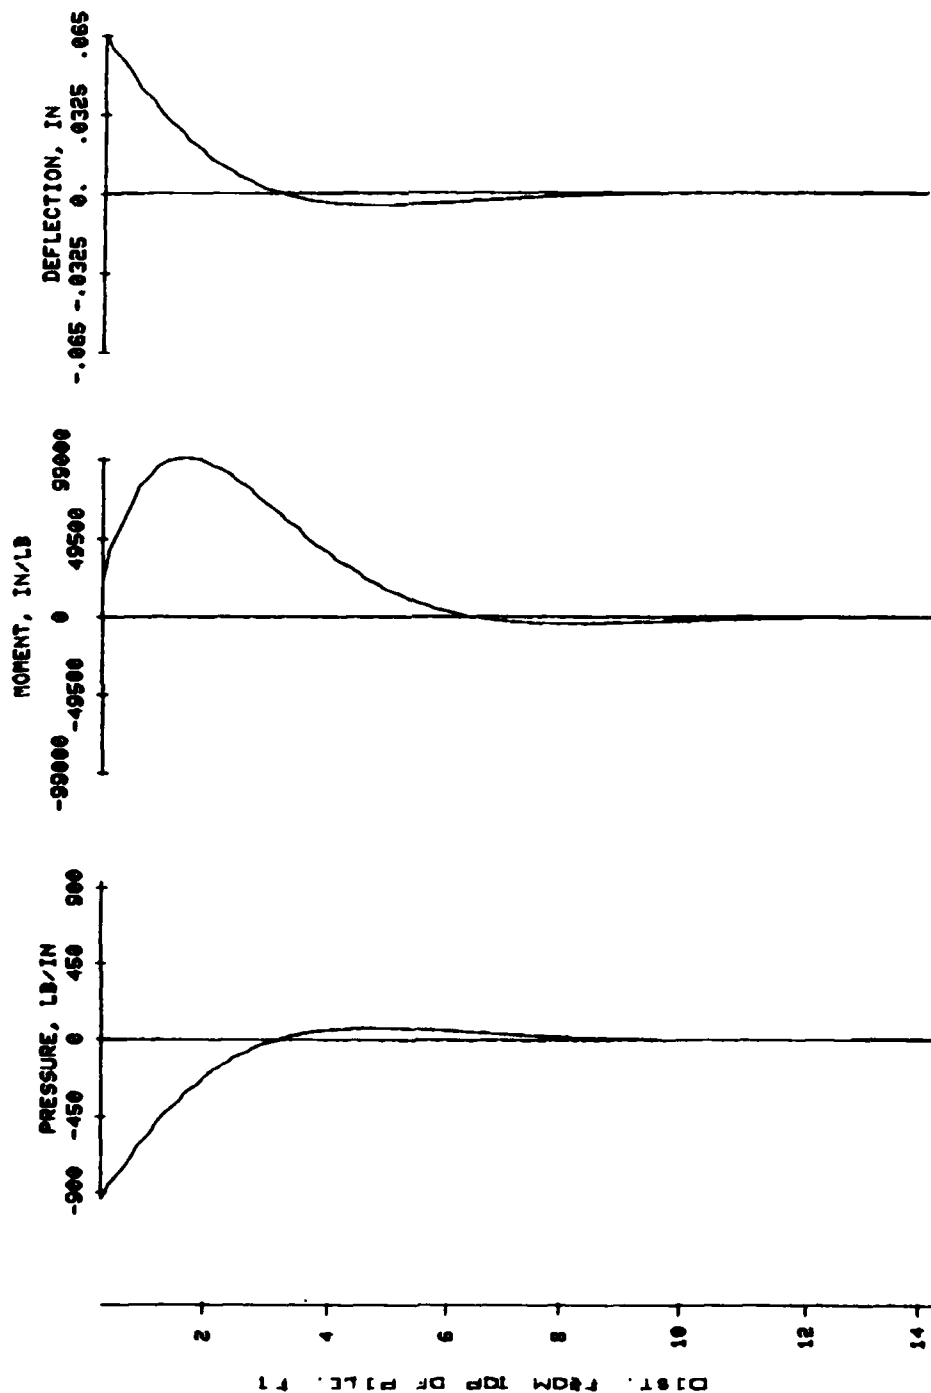
Figure 38. Pressure, moment, and deflection along the length of the most critically loaded pile

78. The pressures, moments, and deflections along the length of the pile for the most critical load case (high-water condition) is presented in Figure 38. The maximum and minimum stresses in the pile due to the applied loads and moments are 950 psi compression and 580 psi tension.
